**VIRGIN ISLANDS DEPARTMENT OF AGRICULTURE  
COASTAL CONSISTENCY DETERMINATION REQUEST**

**DEMOLITION OF ADMINISTRATION BUILDING  
ST. CROIX, U.S. VIRGIN ISLANDS**

**GRANT MANAGER: #88176  
FEMA APPLICANT ID: #000-UB4BN-01  
October 15, 2021**

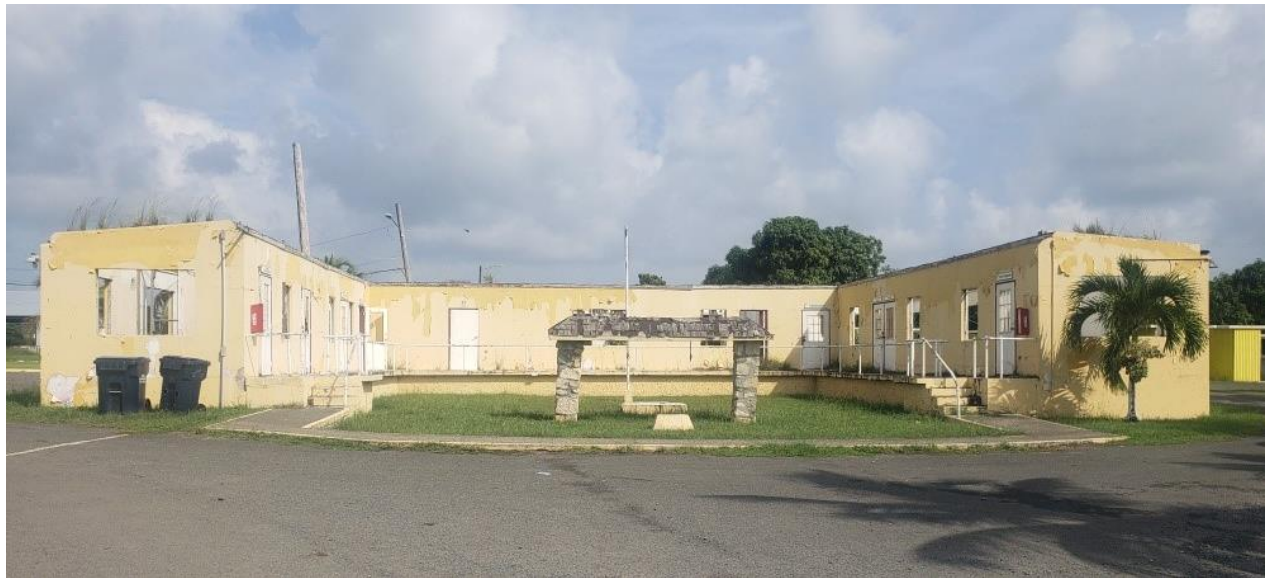
*Figure 3 - South (Front) Elevation View of Administration Building - Post Storm*

The demolition of the Administration Building will remove the existing elevated one-story masonry structure that was catastrophically damaged by Hurricane Maria. The proposed demolition project will impact only previously disturbed areas associated with the removal of the existing Administration Building, including the existing foundations. The proposed project is the initial step in the permanent restoration of the existing administrative services for the department of agriculture. The proposed project will begin as soon as all approvals have been finalized and will take an approximately 30-days to complete the demolition.

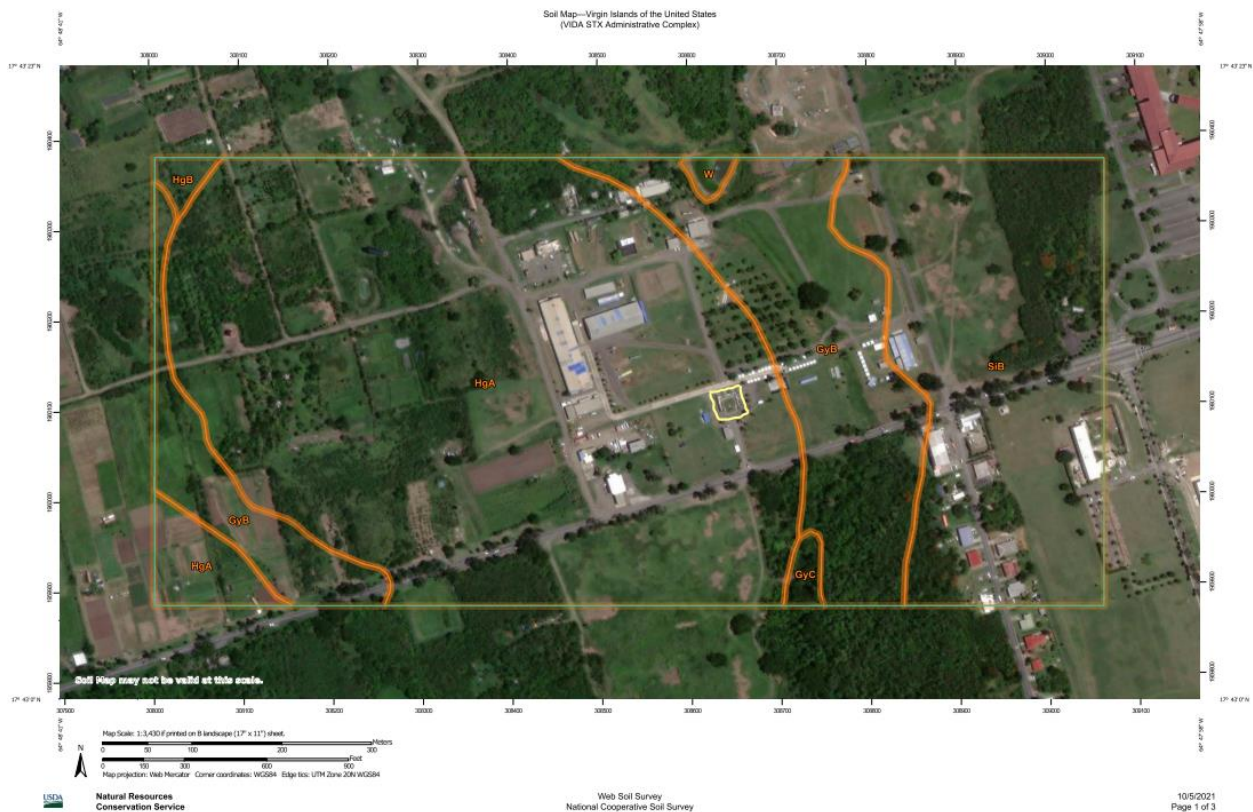
*Figure 6 - The composition of soils within the area of the Administration Building demolition project. The project falls within the area of the yellow box area.*

The soil composition of the area of the Administration Building project site is Hogensborg clay loam, 0 to 2 percent slopes. The Hogensborg series consists of very deep, well drained, very slowly permeable soils on alluvial fans and terraces. They formed in clayey sediments. All work is being done in areas that have already been disturbed.

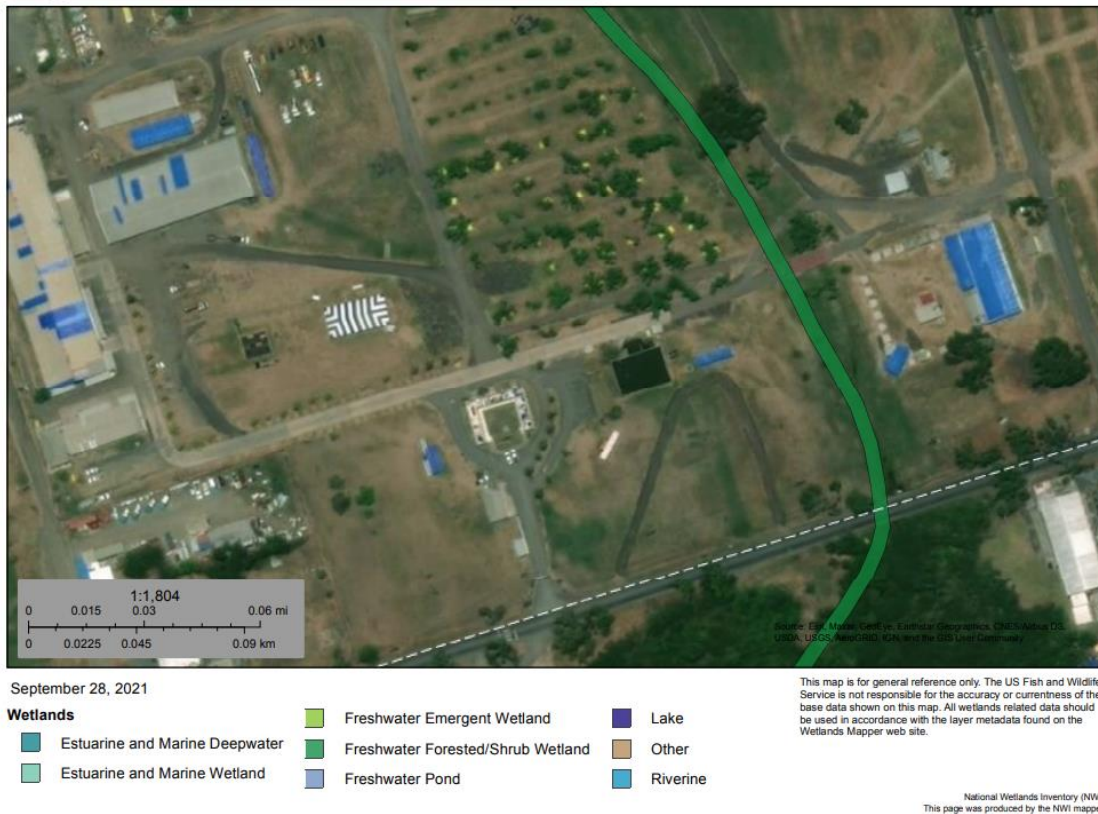
Figure 8 - The relationship between the proposed Administration Building demolition and wetlands.

The project will have no impact on wetlands, as there are no wetlands in, or adjacent to, the proposed project site.
